Machinery Messages

Case history

Transient Data Manager® 2 plots identify steam turbine generator problems

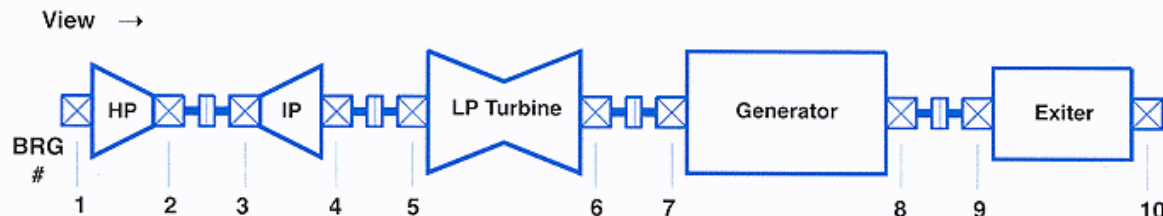
Kilroot Power Station, located in Carrickfergus, Northern Ireland, has two 300 MW turbo-alternators with dual oil or coal-fired boilers and two 30 MW gas turbines. The first 300 MW unit went into service in 1980. The station was acquired in 1992 by two companies involved in power production, Applied Energy Services (USA), and Tractebel SA (Belgium). The new company created is called NIGEN.
